# Navajo Abandoned Uranium Mine Site Screen Report

## **Ruby No. 3 AUM Site**

### **Navajo AUM Eastern Region**

**May 2009**

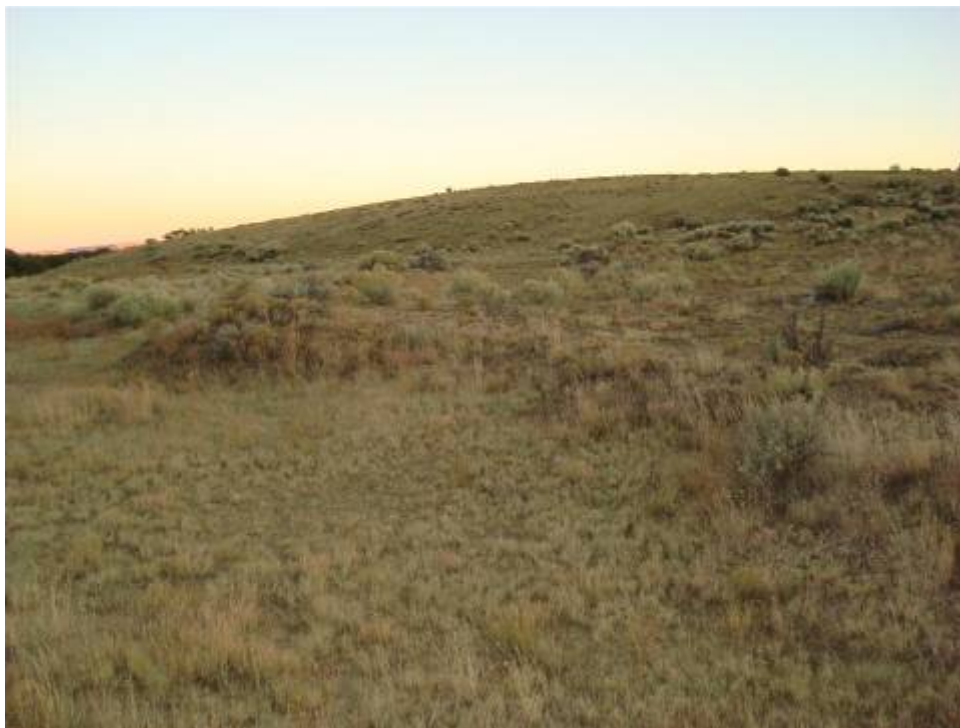
Photo 1. Ruby No. 3 Mine site, towards the south

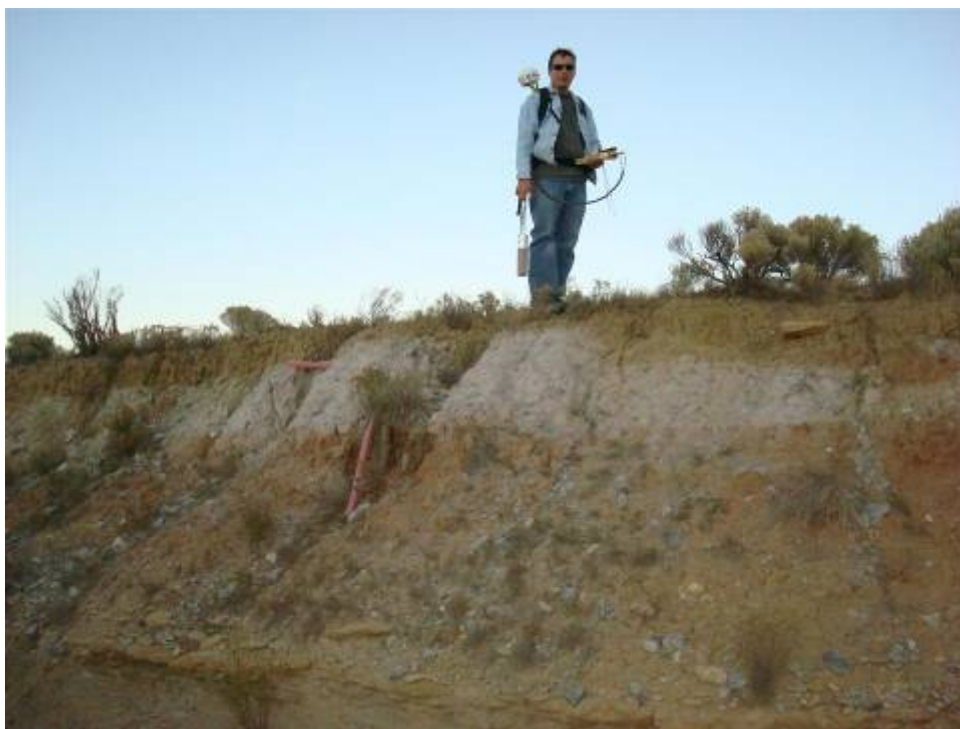
Reclamation status of the mine sites are currently unknown. The mine appears to have been covered with a soil cap. A few areas of the cap have eroded to expose waste rock beneath. Some uranium ore or waste rock was mixed in with the cover soil. No waste piles, adits, or other mine features were observed during the site visit.

**Is the cap/seal functionally intact?** Erosion of the soil cap was observed at a few areas.

Photo 2. Ruby No. 3 Mine site, erosion of western edge of mine

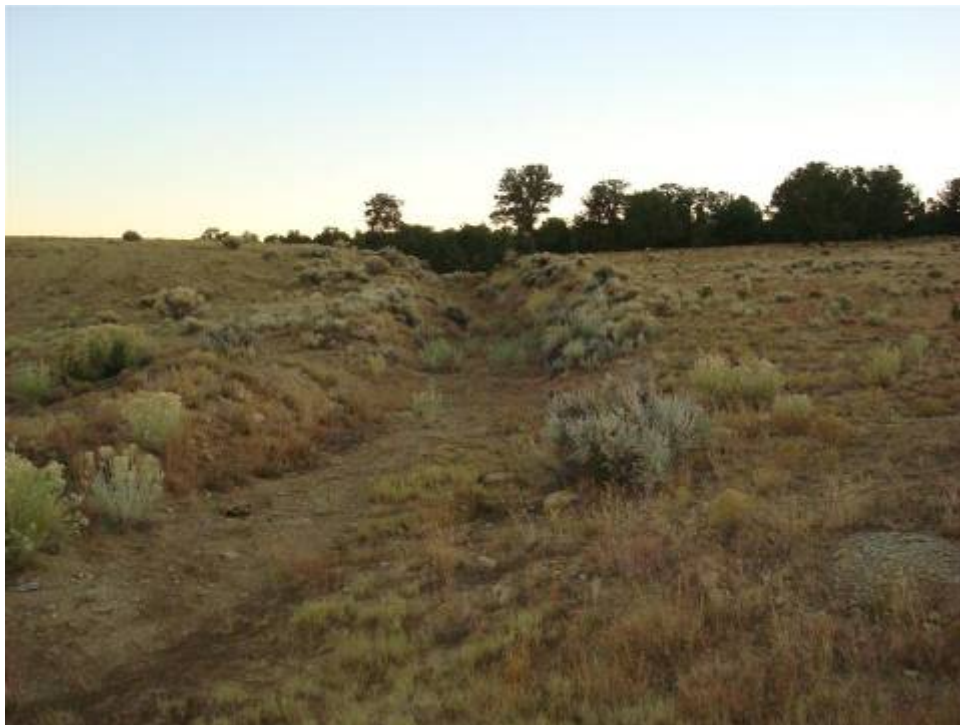
Photo 3. Ruby No. 3 Mine site, erosion of southern portion of mine

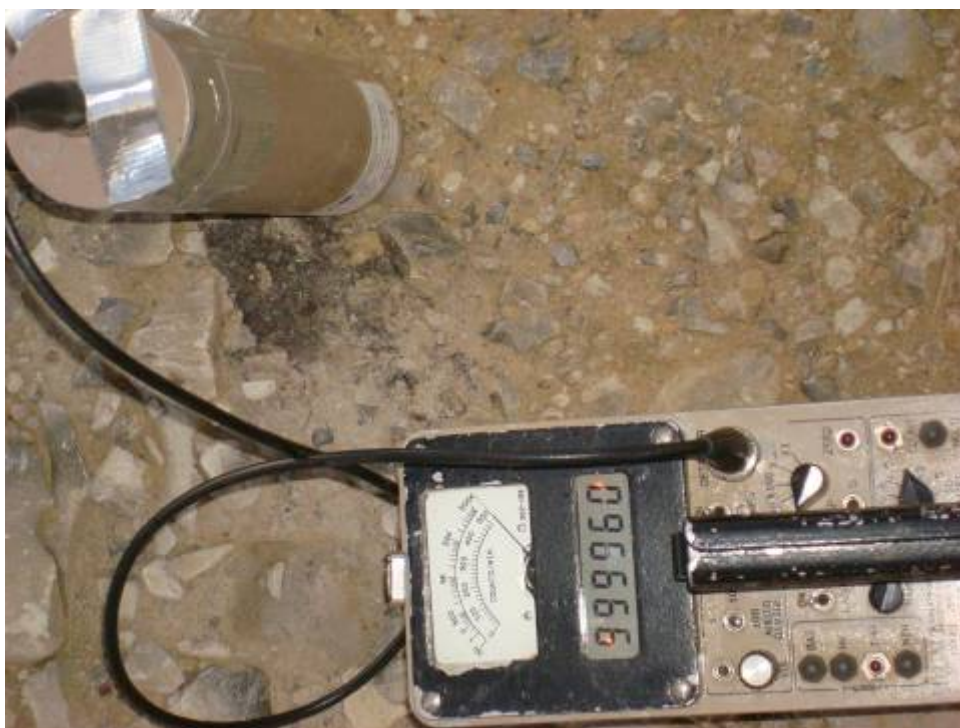
A total of 2,911 gamma radiation measurements were collected from mine sites, ranging from 9,146 cpm to 969,089 cpm. The measurements are represented in Figures 1 and 2. The highest radiation was emitted from exposed uranium found in the road at the central portion of the mine and was beyond the meters measuring capabilities of 999,999 cpm. Gamma radiation measurements collected from the Augustine Largo residence, located within ¼ mile from the mine, were approximately 12,000 cpm.

Photo 4. Ruby No. 3 Mine site, very high gamma radiation emitting from black uranium ore

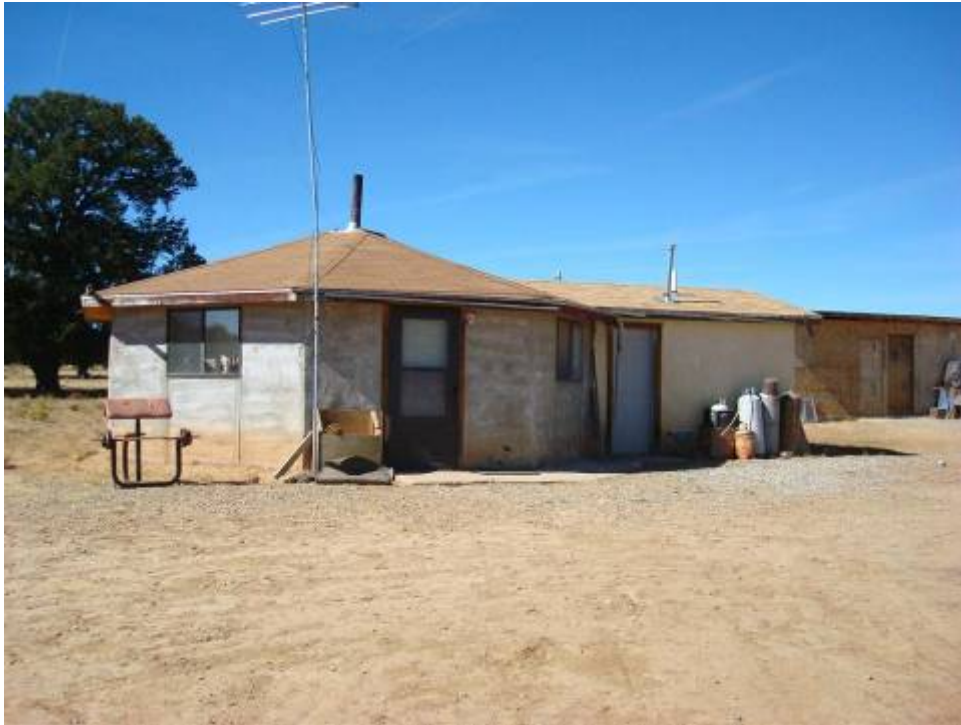
**At what distance from the cap/seal is the nearest domestic structure located?** 0.18 mile

Photo 5. Ruby No. 3 Mine site, Augustine Largo residence within ¼ mile of mine

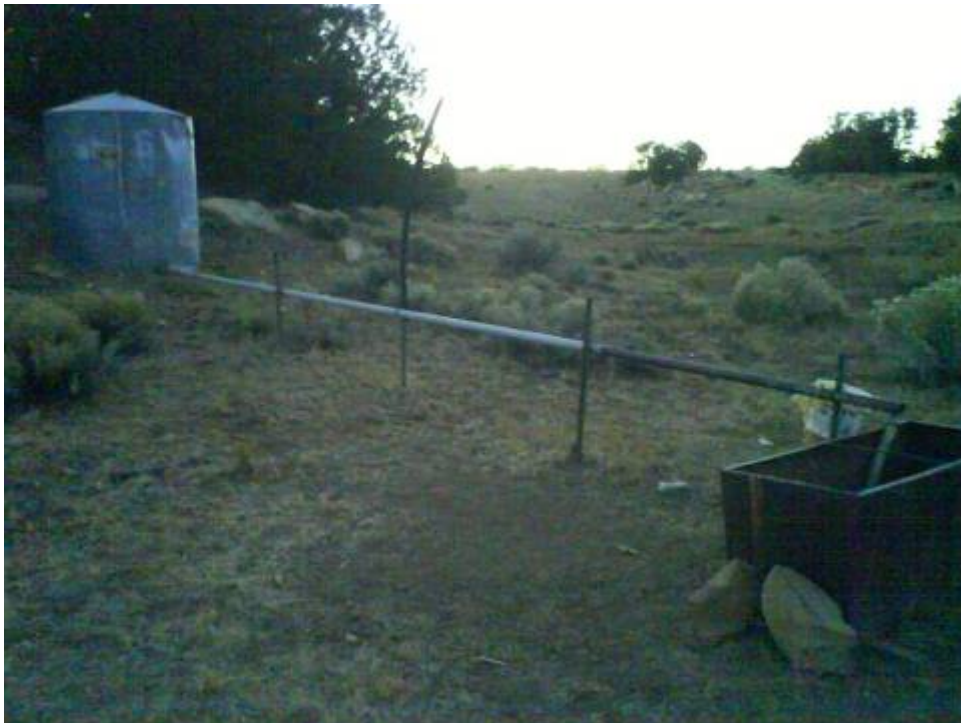
Photo 6. Ruby No. 3 Mine site, water tank and livestock watering trough located approximately 200 feet southeast of mine. Mine is in background
